HISTORIC STRUCTURE ASSESSMENT REPORT

**SULLIVAN'S ISLAND COAST GUARD STATION
BUILDING FOS11
FORT SUMTER NATIONAL MONUMENT**

Dates of Inspection and
Condition Assessment Report: 1991

Inspected by:
Center for Architectural Conservation
College of Architecture
Georgia Institute of Technology
Atlanta, Georgia 30332-0155

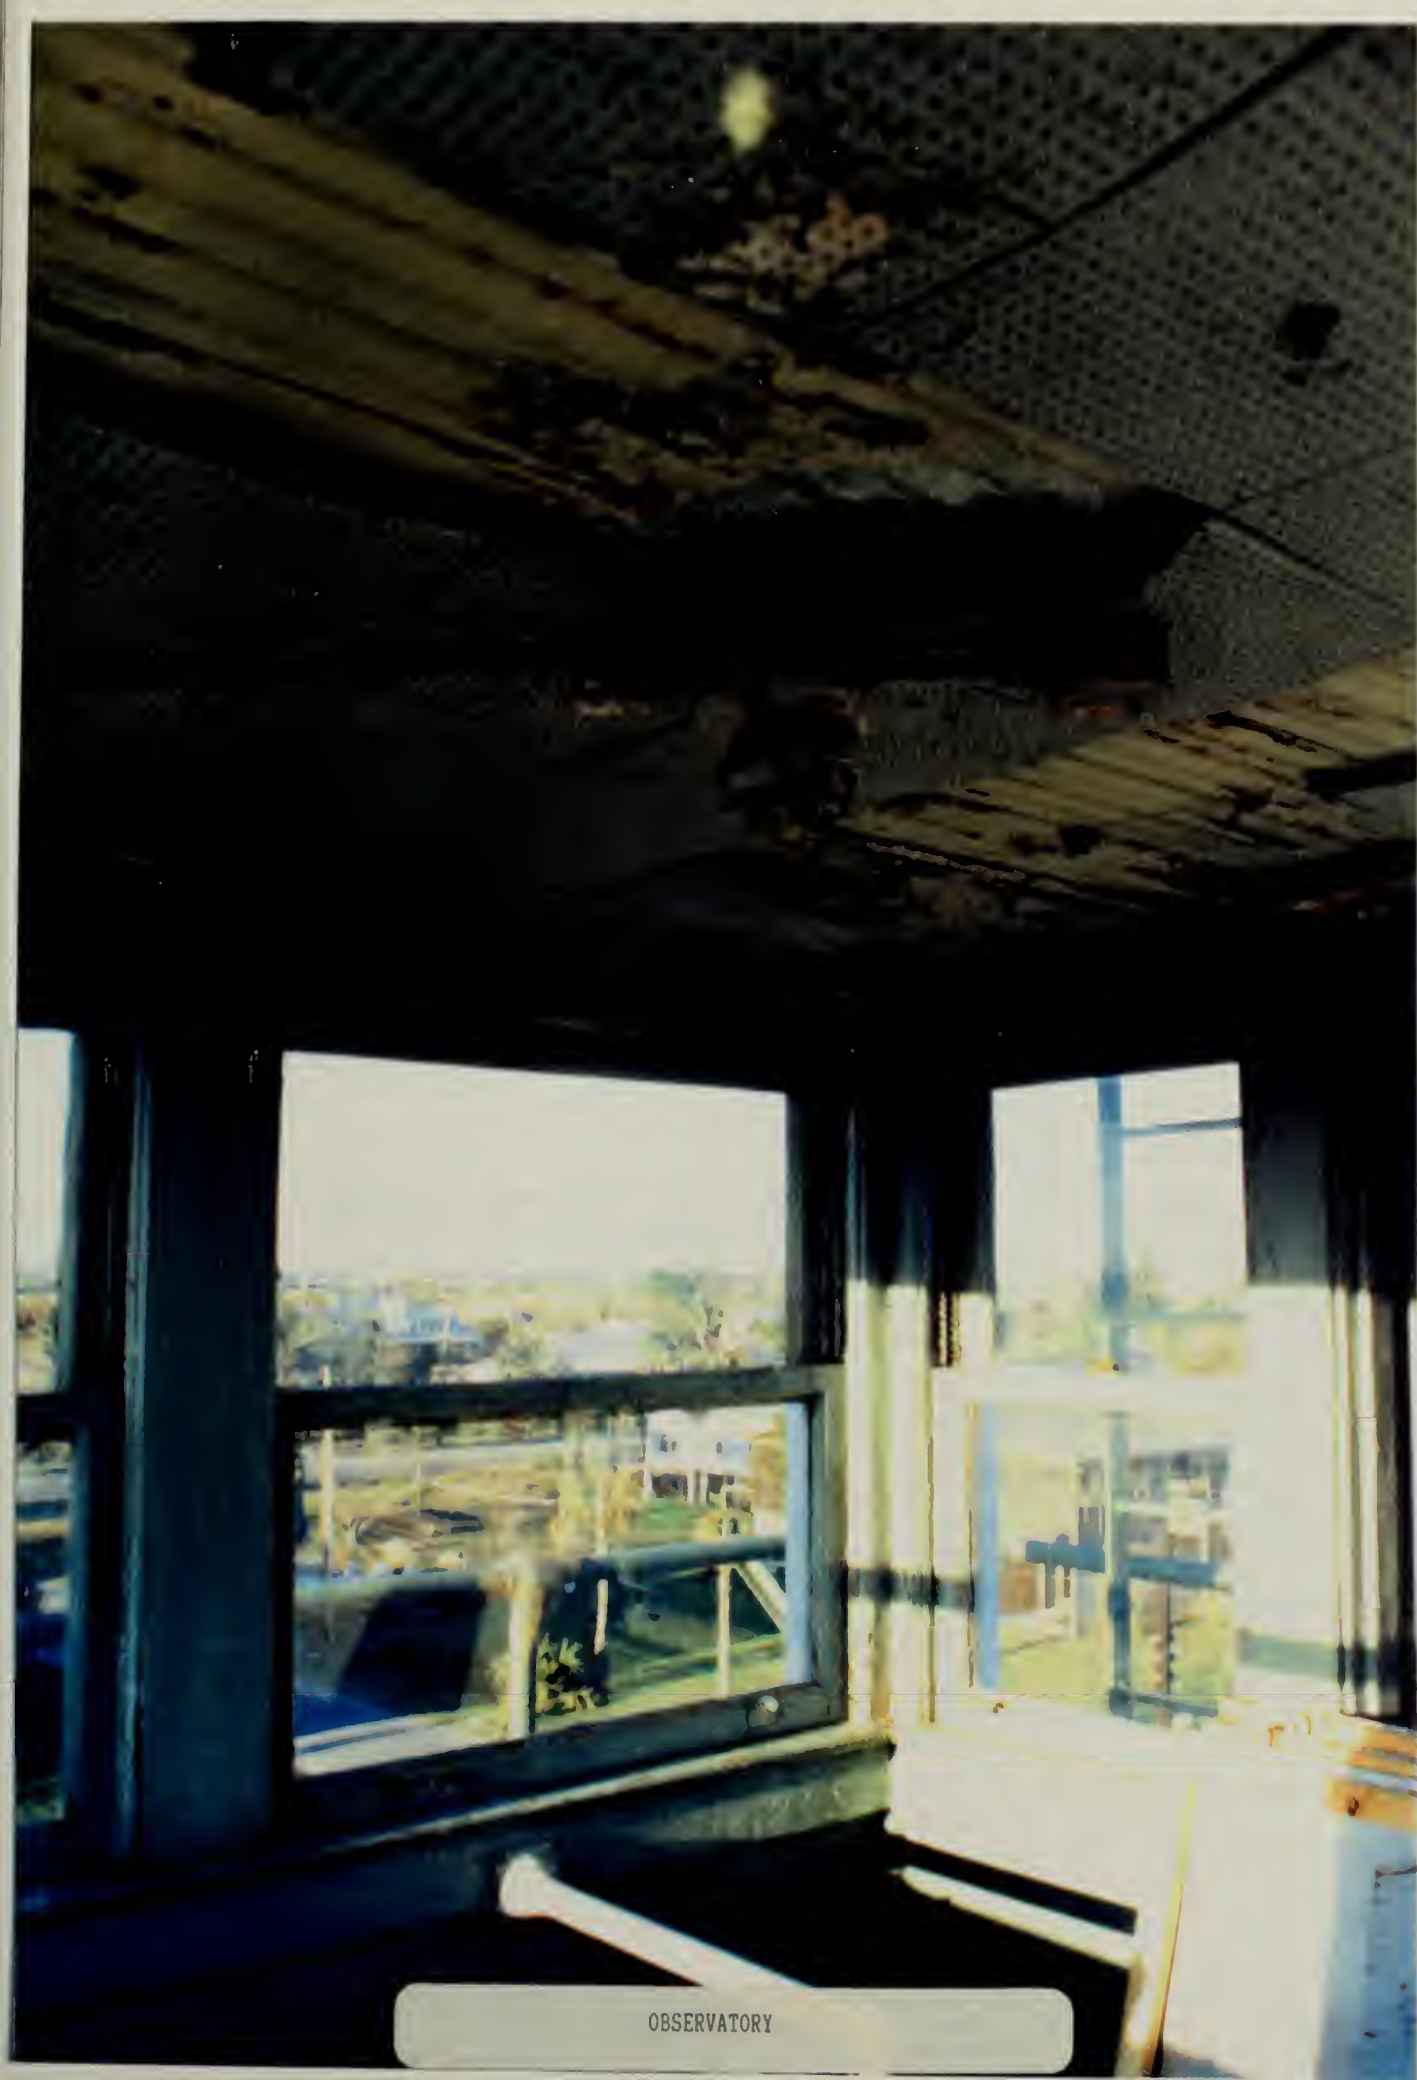
OBSERVATORY

\$ 325
4141	WINDOWS WDO FRAME PRIORITY: CRITICAL CONDITION: POOR SOURCE: Means RATING: 2/4	Deterioration of window frames of observatory sash	Remove sash/repair frames as required to match surrounding sound areas/reinstall sash	4	EA	\$ 150 500 195 =====
						\$ 845
4143	WINDOWS WDO TRIM PRIORITY: MINOR CONDITION: POOR SOURCE: Means RATING: 2/4	Utility room window trim is rusty & damaged	Remove paint & rust from the damaged parts/repair as required to match surrounding areas/apply 1 prime coat & 2 top coats of rust inhibiting paint	8	LF	\$ 50 250 90 =====
						\$ 390
4144	WINDOWS WDO GLAZING PRIORITY: SERIOUS CONDITION: POOR SOURCE: Means RATING: 3	Broken & cracked panes of glass	Remove cracked & broken glass provide single pane glass the same size & install	4	EA	\$ 50 150 60 =====
						\$ 260
4145	WINDOWS WDO HARDWARE PRIORITY: SERIOUS CONDITION: POOR SOURCE: Others RATING: 3	Broken & missing window lifts & locks	Remove broken hardware/install new brass hardware as required matching remaining hardware	15	EA	\$ 225 400 188 =====

4313	SYSTEM ROOF STRUCTURE PRIORITY: CRITICAL CONDITION: POOR SOURCE: Others RATING: 2	The original observatory roof structure replaced at some point with inappropriate flat roof	Remove existing roofing & metal cap flashing/provide 2"x6" wood rafter & build up gable structure on the observatory roof similar to elevations titled US Coast Guard	108	SF	\$ 300 2000 690 =====
						\$ 2990
4314	SYSTEM ROOF INSULATION PRIORITY: SERIOUS CONDITION: POOR SOURCE: Means RATING: 6	There is no insulation in the roof area	Provide 3 1/2" thick batt insulation (R-30) & insert between the joists	600	SF	\$ 200 150 105 =====
						\$ 455
4340	FLASHING ROOF FLASHING PRIORITY: CRITICAL CONDITION: POOR SOURCE: Means RATING: 3	Damaged & rusty flashing & missing flashing around the connection of the observatory walls & the roof	Remove all rusty & damaged flashing/provide aluminum flashing & replace/install flashing in the connection of the observatory walls with gable roof area	104	LF	\$ 200 500 210 =====
